SUBJECT: Summary and Recommendations for the Safety-Kleen Corporation  
site, Brentwood, St. Louis County, Missouri.  
TDD #F-07-9003-006 PAN #FM00905RA  
Site #S18 Project #001  
Superfund Contact: Greg Reesor  
RCRA Contact: Patricia Nichols  
FIT Project Leader: Rob Parsons

EPI-Preliminary Assessment  
Safety-Kleen

Brentwood, Missouri

SUBJECT: EPI Preliminary Assessment for the Safety-Kleen Facility site,  
Brentwood, Missouri.  
TDD #F-07-9003-006 PAN #FM00905RA  
Site #S18 Project #001  
Superfund Contact: Greg Reesor  
RCRA Contact: Patricia Nichols  
FIT Project Leader: Rob Parsons

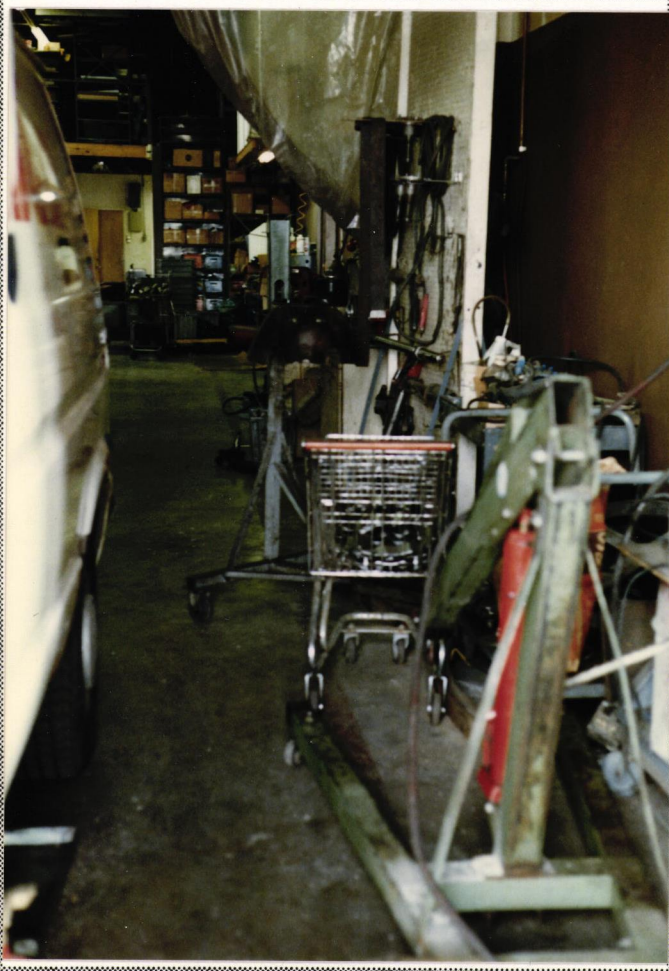
No.:  
Subject 1

Photo Number	Photo Description
1	Former Drum Storage Area
*2	Former Underground Storage Tank Location
*3	Former Underground Storage Tank Location
*4	Former Underground Storage Tank Location

The drum storage area occupied a 30-foot by 5-foot area inside the warehouse along the north side of the center wall. The floor of the building was constructed of concrete slab with expansion joints and no floor drains. During the VSI, the floor was observed to be in sound condition. Spent solvents were stored in this area for less than 90 days and then shipped to a recycling center for processing. This area had a storage capacity of 188, 16-gallon immersion cleaner drums and 12, 16-gallon mineral spirits (dumpster mud) drums. Inspection procedures for this unit during its period of operation are unknown.

No file information is available that details the actual type of containment for this area at the time of facility operation. No containment features were observed during the April 1990 site visit.

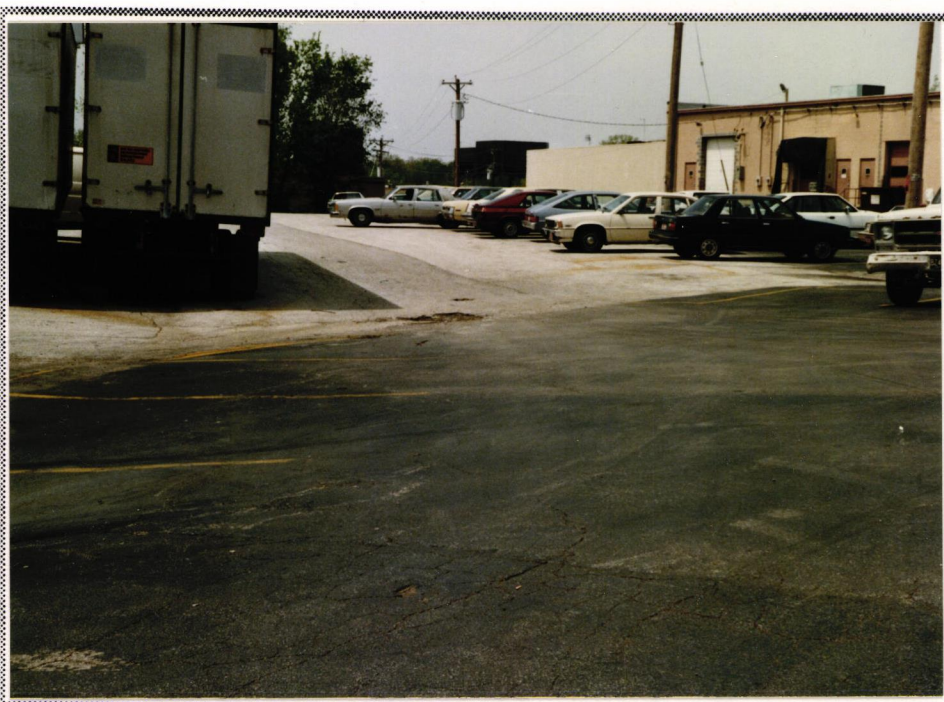
No.: 4  
Subject

Former Underground  
Storage Tank  
Location

These two underground storage tanks were constructed of carbon steel and had respective capacities of 6,000 and 10,000 gallons (Safety-Kleen 1985a). The underground tanks were removed and contaminated soil was excavated during closure.

Available file information did provide data from samples taken during closure and removal of this unit which indicated a release in the subsurface soils around the tanks. A subsequent cleanup of this area occurred and was certified to be clean by the Missouri Department of Natural Resources (MDNR).
